Use of a Hyaluronic Acid Scaffold to Augment Achilles Tendon Repair with Haglund's Deformity: A Case Report

Integrity™ Case Report

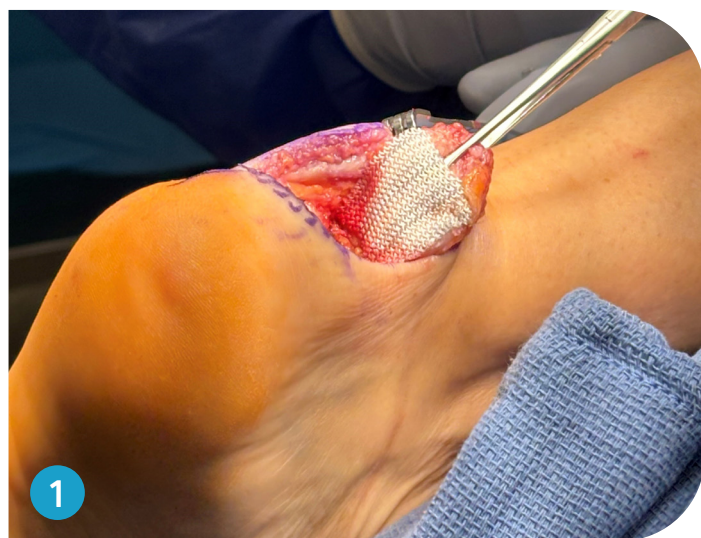
Figure 1. Placement of the Integrity scaffold underneath the Achilles tendon.

Clinical and advanced imaging findings were discussed with the patient and after thorough discussion of risks, benefits, and complications, surgical intervention was deemed appropriate. Due to the patient being at high risk due to her BMI, surgery would consist of Haglund's deformity/retrocalcaneal spur resection, detachment with reattachment with double row technique, and secondary repair of Achilles tendon with utilization of a hyaluronic acid scaffold to augment the tendon with advancement due to the tear.

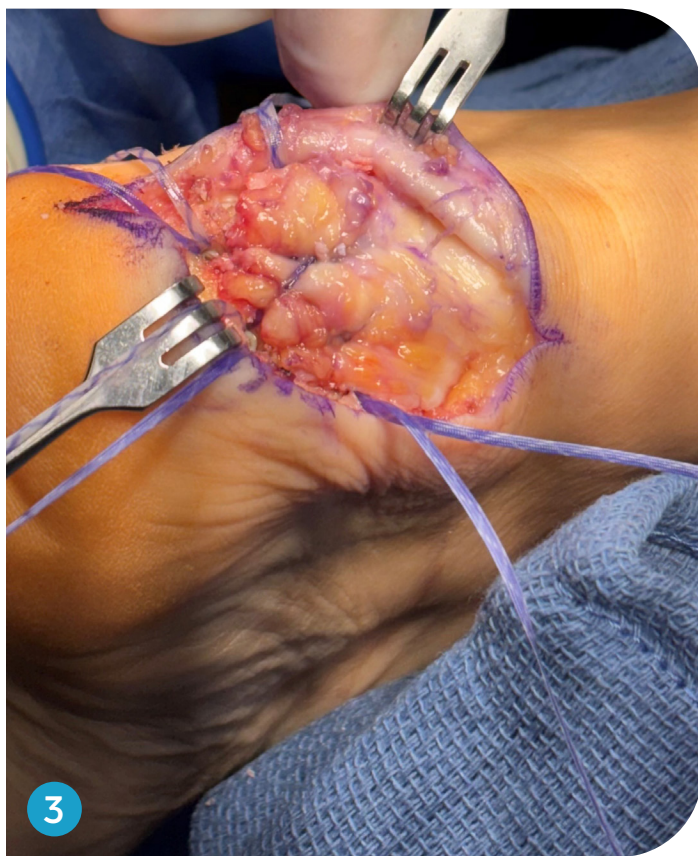
Once the Integrity implant was secured in place, the tendon was tied back down to the bone. A double row tied proximally was pulled down to allow tendon flush over the area of the anchors then using double row technique the tendon was secured to the back of the calcaneus (Figure 3). The two other suture tapes were attached to the anchor and then placed through the tendon medially and laterally to augment the repair site then cut flush to prevent prominence.

Figure 3. A double row tied proximally was pulled down to allow tendon flush over the area of the anchors then using double row technique the tendon was secured to the back of the calcaneus.
