# Use of a Hyaluronic Acid Scaffold to Augment Achilles Tendon Repair with Haglund's Deformity: A Case Report

# Integrity™ Case Report

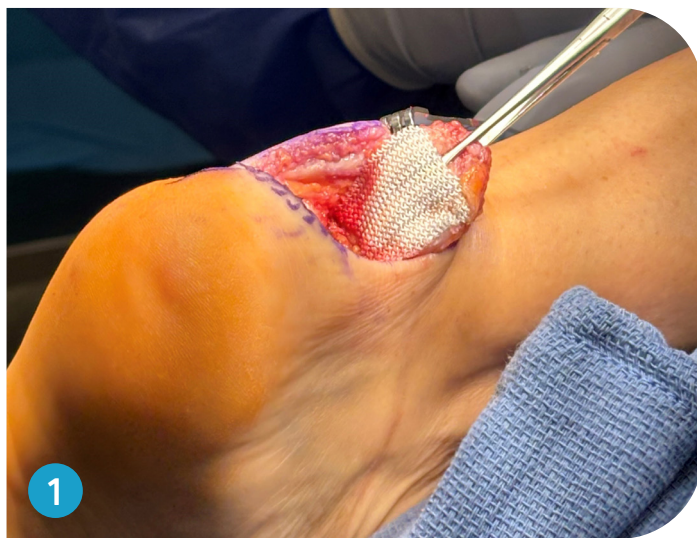
**Figure 1.** Placement of the Integrity scaffold underneath the Achilles tendon.

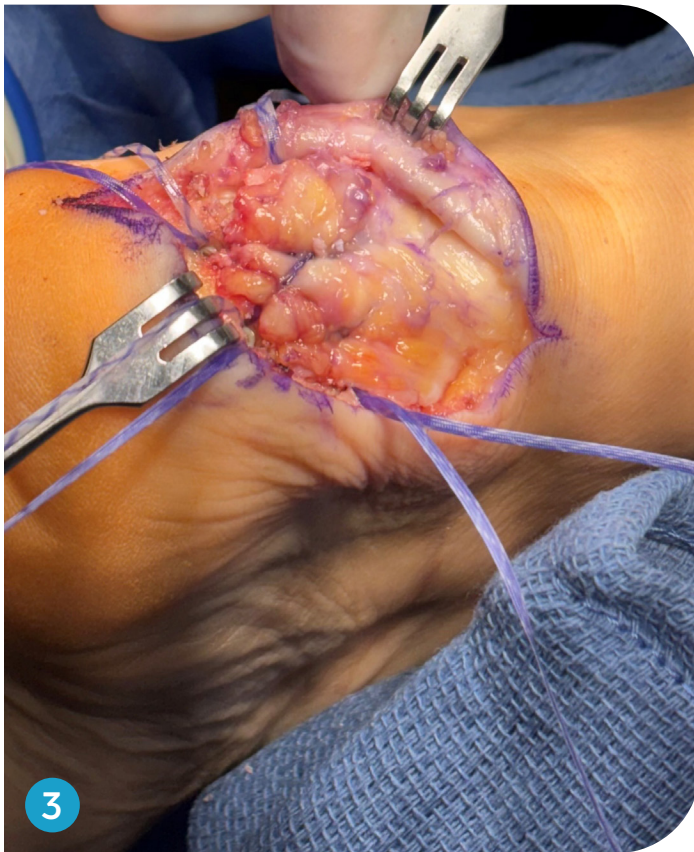
Once the Integrity implant was secured in place, the tendon was tied back down to the bone. A double row tied proximally was pulled down to allow tendon flush over the area of the anchors then using double row technique the tendon was secured to the back of the calcaneus (Figure 3). The two other suture tapes were attached to the anchor and then placed through the tendon medially and laterally to augment the repair site then cut flush to prevent prominence.

**Figure 3.** A double row tied proximally was pulled down to allow tendon flush over the area of the anchors then using double row technique the tendon was secured to the back of the calcaneus.
