# Integrity™ implant for massive rotator cuff tear in 49-year-old active female

**Brian Badman, MD**

*Shoulder Surgeon, Central Indiana Orthopedics*

# Integrity™ Case Report

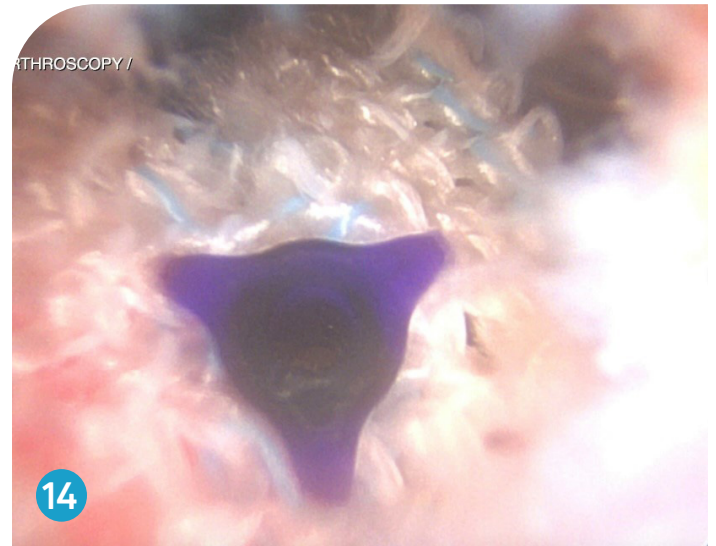
**Figure 14.** Fixation of Integrity implant with tacks.

Next, using the rolling device, the implant was unfolded and deployed over the top of the repaired tendon covering the majority of the tendon insertion point laterally, from anterior to posterior, spanning approximately 20mm in length. Finally, working through two accessory percutaneous portals, five of the 7mm bioresorbable tacks were then used to fixate the implant medially and centrally [Figures 14-15].

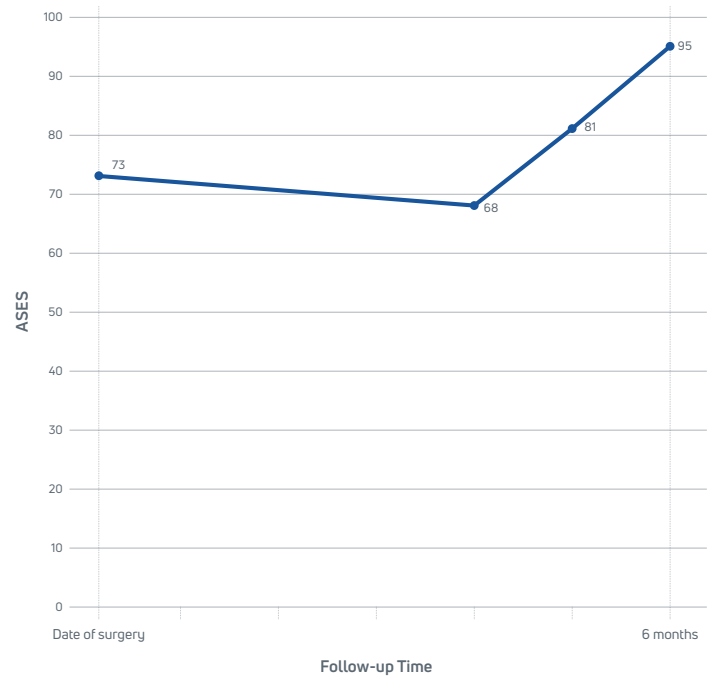
Figure 24. Postoperative ASES score.

Patient reported outcomes also revealed an ASES score of 95 and VAS of 0. She was cleared at this visit to resume a progressive home strengthening program [Figures 24-26].
